Article

Effects of Erosion Control Works: Case Study—Grdelica Gorge, the South Morava River (Serbia)

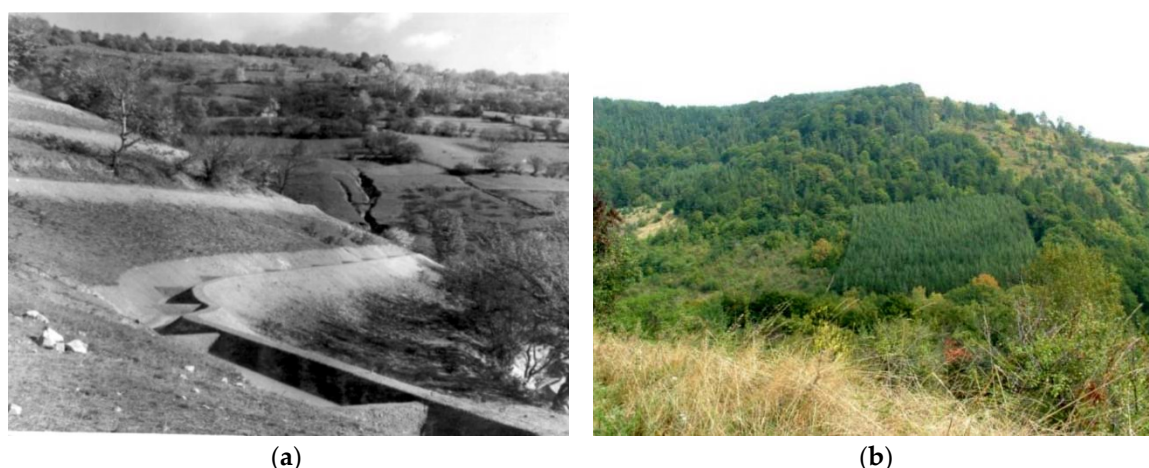
Figure 3. Contour ditches and afforestation of bare land: (a) 1953 [58]; (b) 2016 (photo: S. Braunović).

Biotechnical works included afforestation and grassing of barren land and establishment of orchards on terraced slopes (mild slopes). The species used for afforestation included Austrian pine, Scots pine, walnut, locust, chestnut, Turkish hazel, American ash etc. Grassing and pasture reclamation was carried out using a mixture of grass whose cover ensured the protection of slopes. In the early phases of bench terraces, planting was carried out in one or two rows, which resulted in very dense planting (even 4 seedlings per meter). This method of planting was dismissed because of the low survival rate and poor growth of seedlings and replaced with the one-row planting at a distance of 75 and 100 cm. Planting was carried out in pits. Live wattling was also successfully used (Krpjski potok).

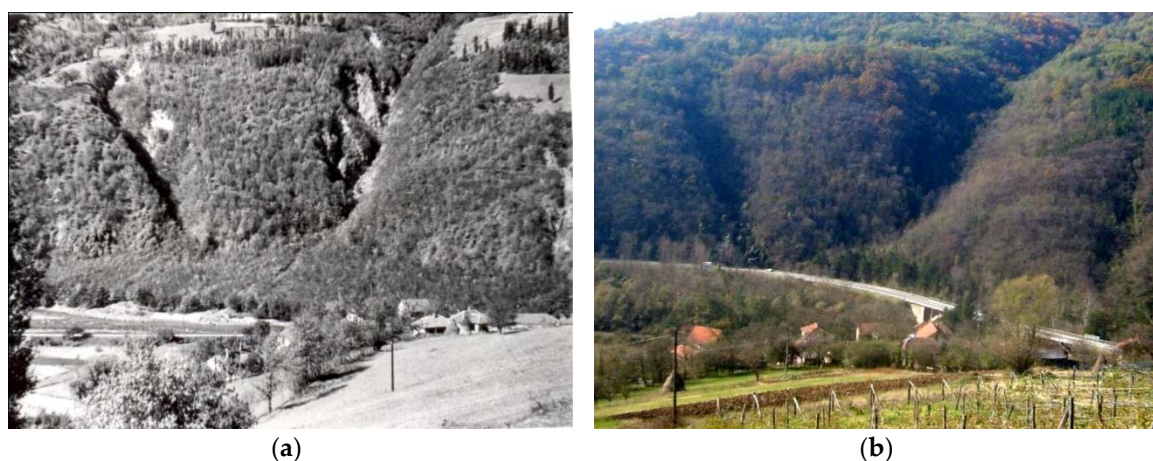
Figure 4. Land use change of Zla Dolina: (a) 1953 [58]; (b) 2016 (photo: S. Braunović).

A particular problem was their equal distribution in the valley of the South Morava and in the hilly mountainous region and the same method of cultivation being applied both on the steep and on the mild slopes. The smallest percentage of arable land was covered with orchards (6.28 km²), i.e., 3.5% of arable or 1.5% of the total area. The barren land formed by deforestation in the zones of watersheds and by planting along slope lines or under the influence of natural characteristics accounted for as much as 22.4% of the area of Grdelica Gorge (Table 5, Figure 4a).

According to the map data from 2016, 55% of Grdelica Gorge area is forestland, 0.57% of which are degraded forests. Meadows and pastures account for 25% of the area, composed of small surface areas near settlements or abandoned weed-covered ploughlands. Ploughlands are less represented (9.35%) and they are located not only along the South Morava but also at higher altitudes, as part of houseyards. These areas are fragmented and scattered. Planting is mostly done along the contour and the ploughland on steep slopes are abandoned. Thus, from the aspect of erosion, there is currently no danger. Orchards account for 1.96% of the area. The remaining parts of the area (10.2%) are unproductive areas: settlements (9.95%) and barren land which now occupy only 0.25% of the Grdelica Gorge area (Table 5, Figure 4b).
